## PHASE II ESA -SUBSURFACE INVESTIGATION

5333 W. 25<sup>th</sup> Street Cicero, Illinois 60804 Cook County

Town of Cicero 4949 West Cermak Road Cicero, Illinois 60804

June 16, 2010

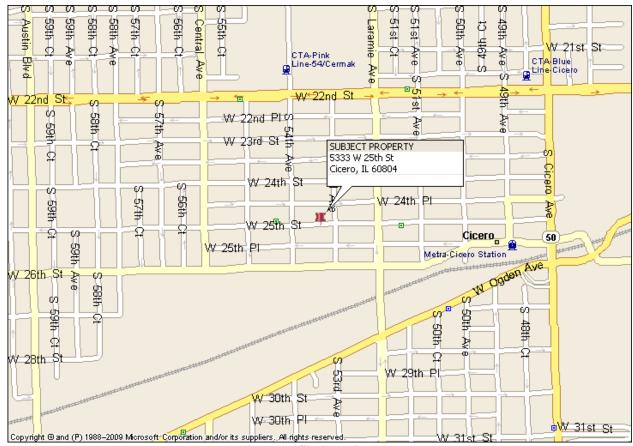
Figure 1 – Site Location Map

The Subject Property is located on the south side of West 25<sup>th</sup> Street between 53<sup>rd</sup> Avenue and 54<sup>th</sup> Avenue. Specifically, the property is located at 5333 W. 25<sup>th</sup> Street in Cicero, Cook County, Illinois (Figure 1).

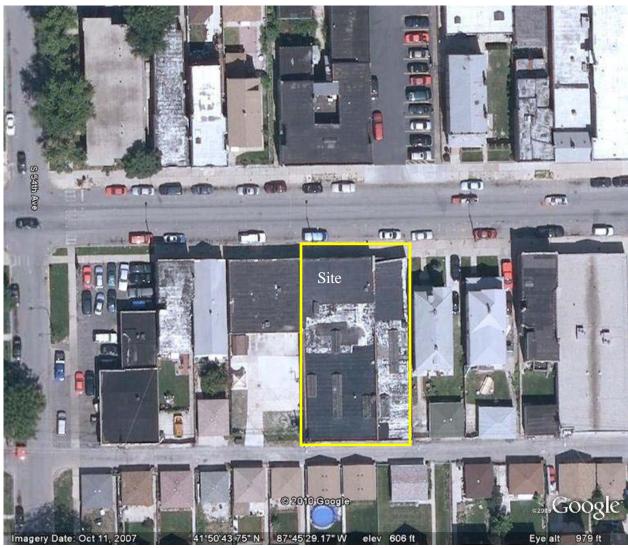
Figure 2 – Site and Surrounding Area (aerial from October, 2007)

The Subject Property is located in a mixed use area. Specifically, the Subject Property is bounded on the **north** by West 25<sup>th</sup> Street, followed by a parking lot and residential apartment building; on the **south** by a public alley, followed by residential family homes; on the **east** by a residential property; and on the **west** by a vacant retail/commercial building, followed by similar properties (Figure 2).

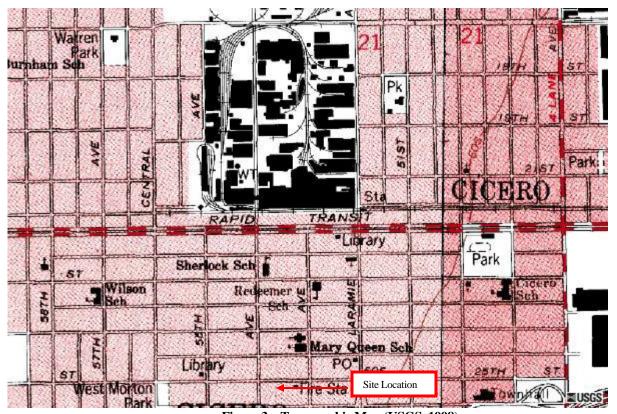
Figure 3 – Topographic Map (USGS, 1998)

In general, the topography of the Subject Property is relatively flat, with no discernible elevation changes. According to the United States Geological Survey 7.5 Minute Series Topographic Map of Berwyn, Illinois Quadrangle (1998), the Subject Property lies at a relative surface elevation of approximately 606 feet above mean sea level. The nearest surface water body is South Branch of the Chicago River which is located within  $2\frac{1}{2}$  of a mile south of the Subject Property. Regional groundwater flow in the area is expected to flow in a southerly direction (Figure 3).

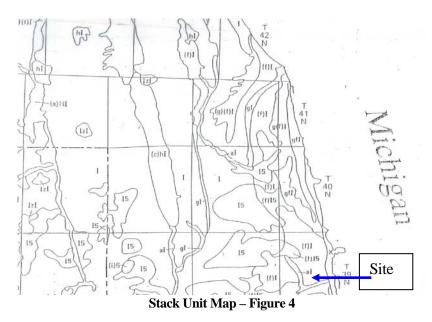
According to the Surficial Geology of the Chicago Region, the geology at the Subject Property consists primarily of soils in the Lake Plain, which consists primarily of floors of glacial lakes flattened by wave erosion and by minor deposition in low areas; largely underlain by glacial till; thin deposits of silt, clay and sand of the Equality Formation present locally. This is corroborated by the Stack-Unit Map, these materials are present at depths greater than approximately 19.7 feet (6 m) thick (Figure 4).

The "Stack-Unit Map" reviewed was compiled by the Illinois State Geological Survey from information collected as a part of a geological mapping project sponsored by the Illinois Environmental Protection Agency. The Stack-Unit Map is a particular way of representing geological data to show the distribution of earth materials vertically from the surface to a specified depth as well as horizontally over a specified area. This map provides a foundation for interpretive maps for assessing potential for contamination from waste disposal sites; construction conditions; groundwater availability; and potential for mineral resources such as sand, gravel, dolomite, limestone, or near-surface deposits of coal. The map makes possible the evaluation of the potential uses of any material or sequence of materials.

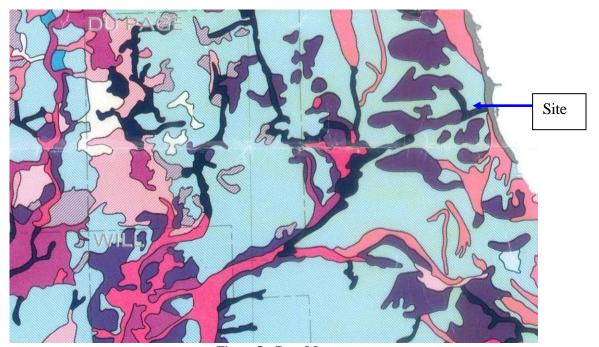
Figure 5 - Berg Map

According to the Berg Map, the regional geologic materials in the area are designated as type as an "E"-type soil (Figure 4). An "E" classification is described as uniform, relatively impermeable silty and clayey diamictons greater than 50 feet in thickness, with no evidence of interbedded sand and gravel.

by Surface and Near-Surface Waste Disposal. These maps were constructed by the Illinois State Geological Survey to describe and map geologic materials to a depth of 50 feet throughout the state. In these maps, various geologic materials were differentiated by thickness, texture, permeability, and stratigraphic position in order to rate their relative contamination potential for aquifers in any area of the state.

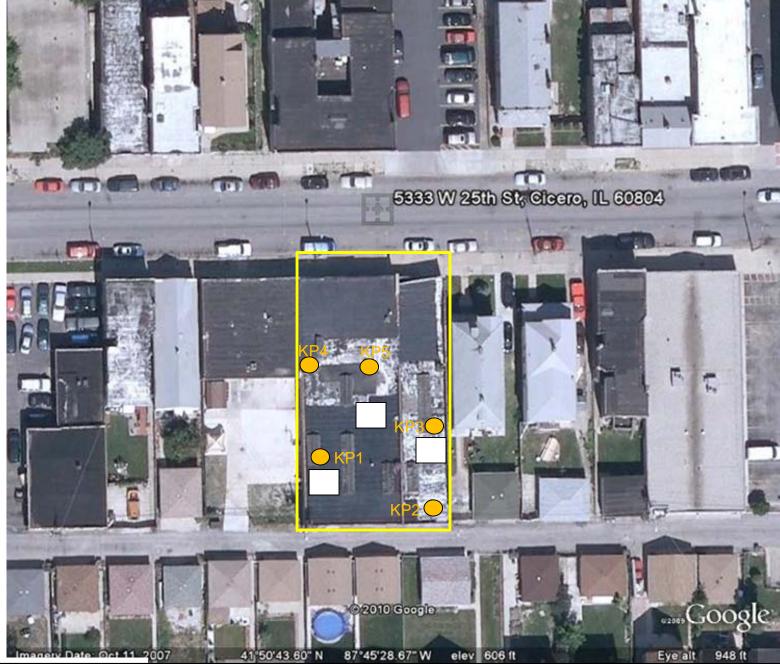
# **Boring Location Map**

In order to evaluate the subsurface soils, a total of five (5) soil borings were advanced to a depth of 12 feet bgs at selected areas of the Subject Property. Soil borings (KP1 through KP5) were performed to determine if the operations at the property, both current and historic, had negative impacts to the subsurface.
